**Flood Control Project Maintenance  
Levee Inspections**

**Fall 2010 Levee Maintenance Deficiency Summary Report**

**Reclamation District No. 0501 Ryer Island**

**Levee Inspection Report By Mile - Fall 2010**

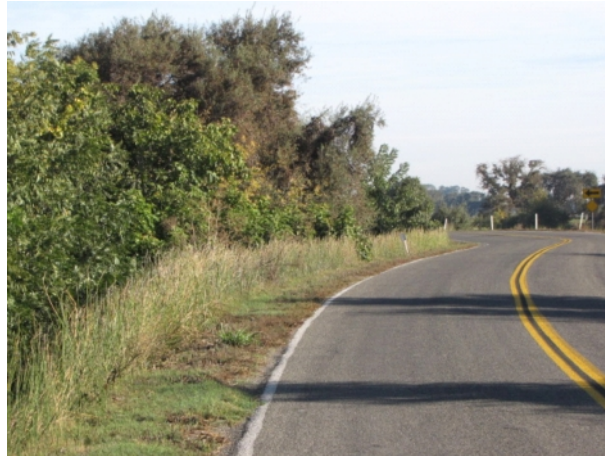
Levee Mile Report Line	1
Start Levee Mile	0.00
End Levee Mile	0.00
Location	Land Side
Category	Earthen Levee
Item	Vegetation
Rd 501 Levee mile 0.00 land side looking downstream from Unit 1, wild growth of walnut trees on slope. Photo taken 11-03-2010	
phillips_f_20101108_298.jpg

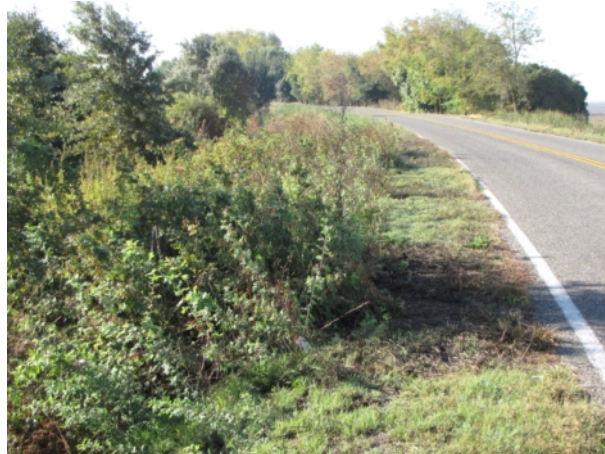
Levee Mile Report Line	1
Start Levee Mile	0.00
End Levee Mile	0.00
Location	Land Side
Category	Earthen Levee
Item	Vegetation
RD 501 Levee mile 0.00 looking downstream from water side. View of wild berries on slope and shoulder. Photo taken 11-03-2010	
phillips_f_20101108_299.jpg

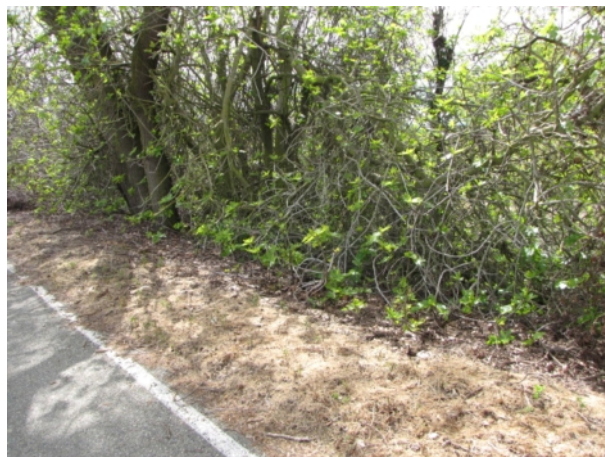
Levee Mile Report Line	4
Start Levee Mile	0.05
End Levee Mile	0.06
Location	Land Side
Category	Earthen Levee
Item	Trim / Thin Trees
photo show wild growth of fog trees on shoulder and slope of levee, not able to see the leve slope at all. Photo taken 11-03-2010	
phillips_f_20101104_297.jpg

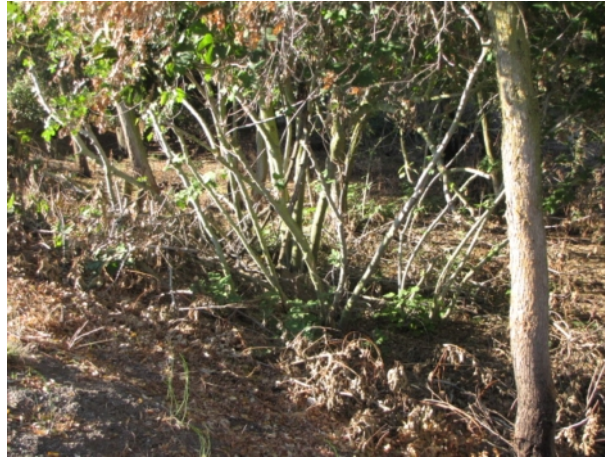
Levee Mile Report Line	5
Start Levee Mile	0.13
End Levee Mile	0.24
Location	Land Side
Category	Earthen Levee
Item	Trim / Thin Trees

levee mile 0.13 District need to remove the Fig trees from levee section on the land side, not trim them up like shown in this photo. All these shown here are less than 2-inches in diameter.

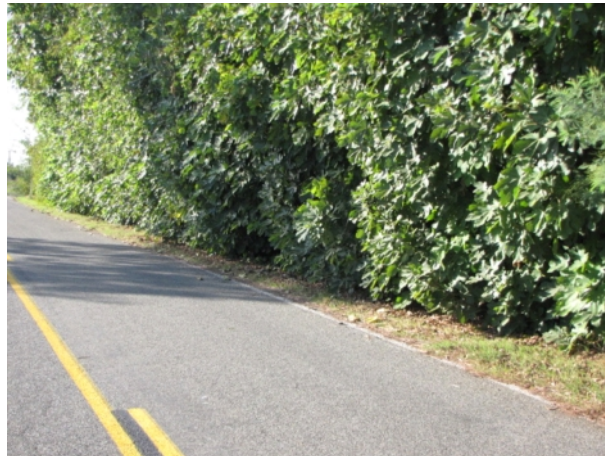
Levee Mile Report Line	7
Start Levee Mile	0.26
End Levee Mile	0.28
Location	Land Side
Category	Earthen Levee
Item	Trim / Thin Trees

This is a view of unsatisfactory Fig growth on the levee section land side looking downstream from levee mile 0.26 to 0.28. This phot was taken 11-03-2010 No change since last inspection.

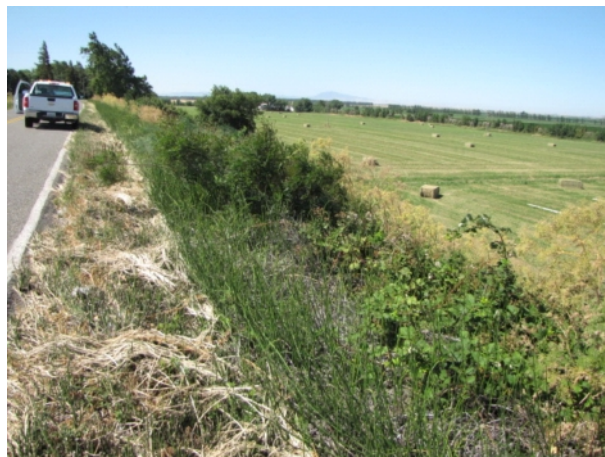
Levee Mile Report Line	17
Start Levee Mile	0.75
End Levee Mile	0.94
Location	Land Side
Category	Earthen Levee
Item	Vegetation

The berries here completely blocks the view of the levee section. Standing at levee mile 0.75 looking downstream to levee mile 0.94. Photo taken 11-03-2010

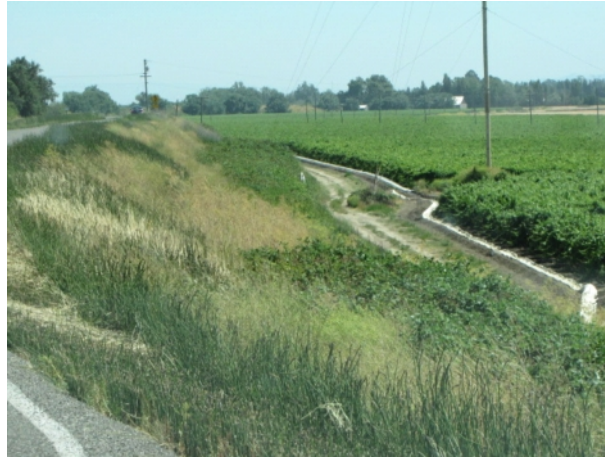
Levee Mile Report Line	21
Start Levee Mile	1.55
End Levee Mile	1.74
Location	Land Side
Category	Earthen Levee
Item	Vegetation

Levee mile 1.55 looking downstream landside slope is covered with wild berries. Taken 11-03-2010

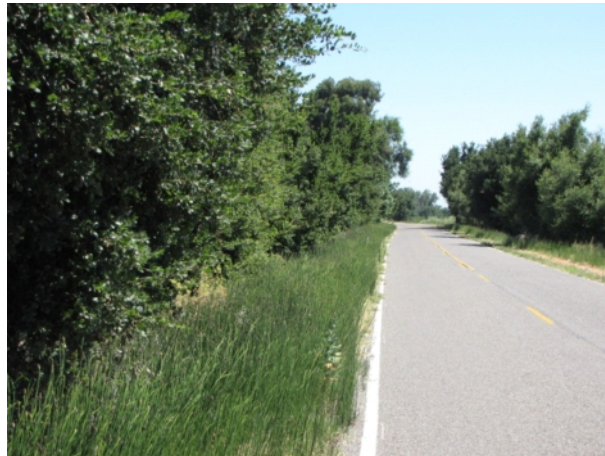
Levee Mile Report Line	32
Start Levee Mile	3.34
End Levee Mile	3.36
Location	Land Side
Category	Earthen Levee
Item	Trim / Thin Trees

Wild growth of trees on the landward shoulder and slope on levee. Standing at levee mile 3.34 looking downstream to levee mile 3.36.

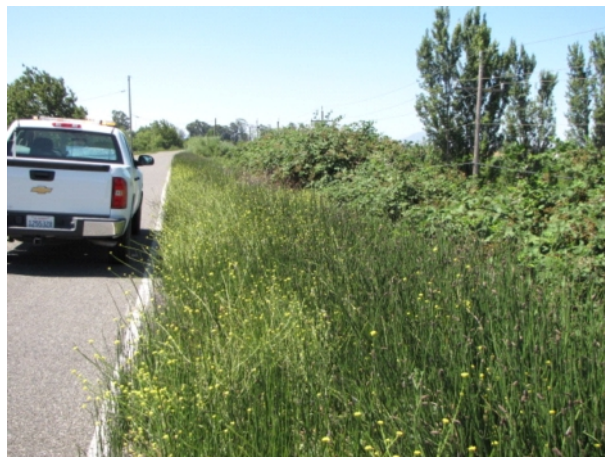
Levee Mile Report Line	40
Start Levee Mile	3.80
End Levee Mile	4.14
Location	Land Side
Category	Earthen Levee
Item	Vegetation

This section here shows that the berry vines are taller than the cab of the truck, you can't see the slope or toe because of the wild growth.

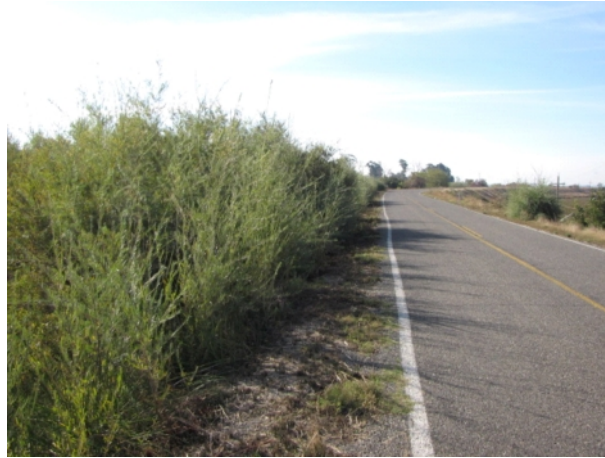
Levee Mile Report Line	41
Start Levee Mile	4.00
End Levee Mile	4.07
Location	Water Side
Category	Earthen Levee
Item	Vegetation
Looking downstream from levee mile 4.00 waterside sadnwillows block view of slope. 11-03-2010	
phillips_f_20101108_302.jpg

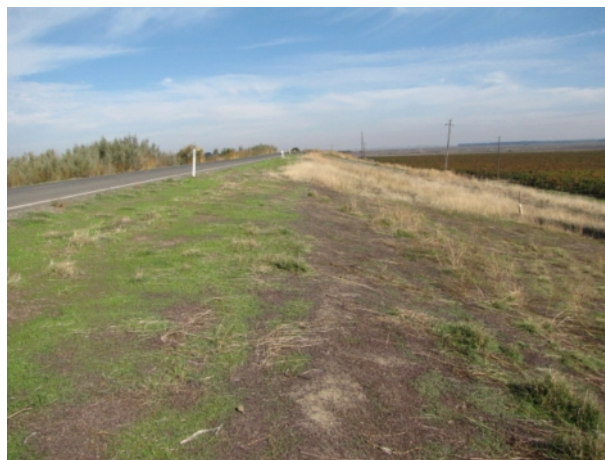
Standing on land side looking down stream from levee mile 0.44 RD 501 Unit 2. Taken 11-03-2010

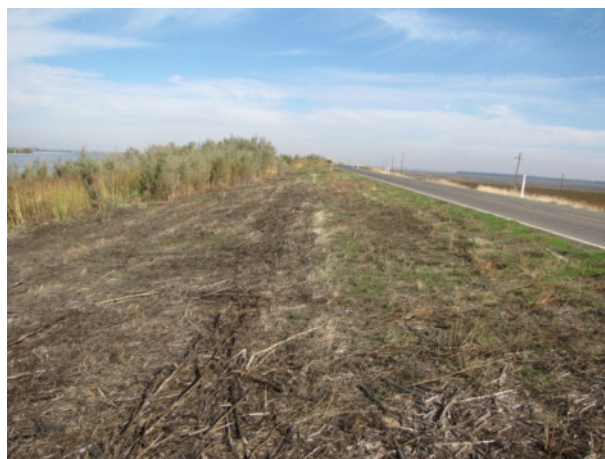
Levee Mile Report Line	5
Start Levee Mile	0.44
End Levee Mile	0.44
Location	Land Side
Category	Earthen Levee
Item	Vegetation

Water side from levee mile 0.44 looking downstream Unit 2 RD 501. Taken 11-03-2010

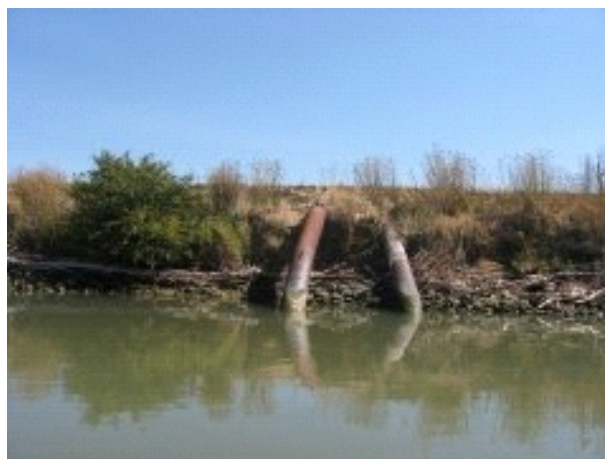
Levee Mile Report Line	10
Start Levee Mile	1.13
End Levee Mile	1.17
Location	Water Side
Category	Supplemental
Item	USACE Erosion Survey

2009: 3 ft berm, 2:1 slope, holes and slumping, clays and cobbles, 10.9 ft/s [2009 SiteID:CHS\_15-9\_L]

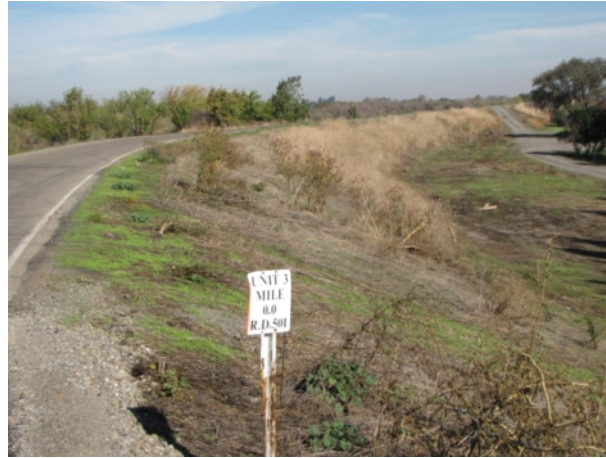
Levee mile 0.00 Unit 3 looking downstream on land side. Taken 11-03-2010

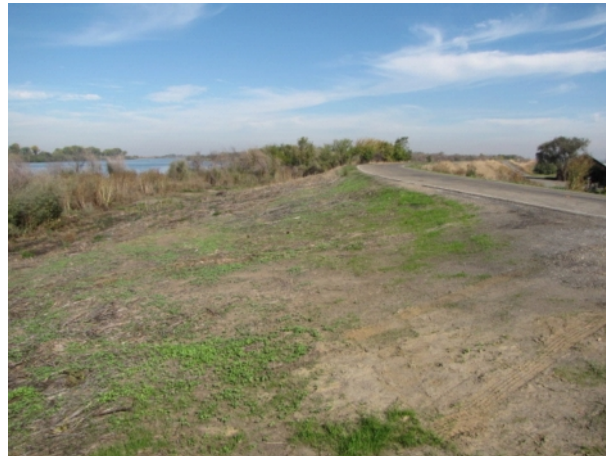
Levee Mile Report Line	1
Start Levee Mile	0.00
End Levee Mile	0.00
Location	Land Side
Category	Earthen Levee
Item	Vegetation

Standing on waterside levee slope Unit 3 RD 501 Levee mile 0.00 looking downstream at levee. Taken 11-03-2010

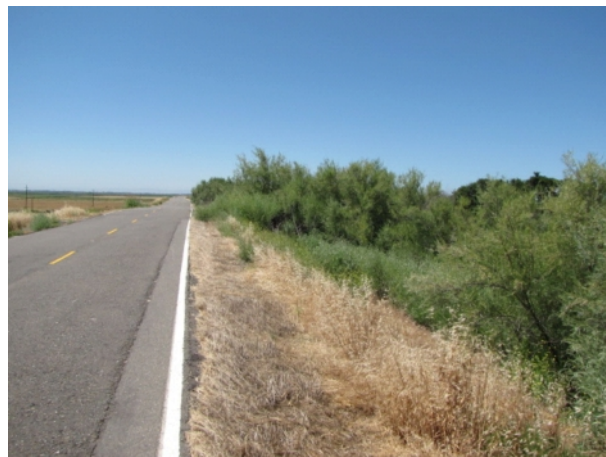
Levee Mile Report Line	8
Start Levee Mile	2.65
End Levee Mile	2.77
Location	Water Side
Category	Earthen Levee
Item	Trim / Thin Trees

2.65 looking upstream from downstream end waterside.

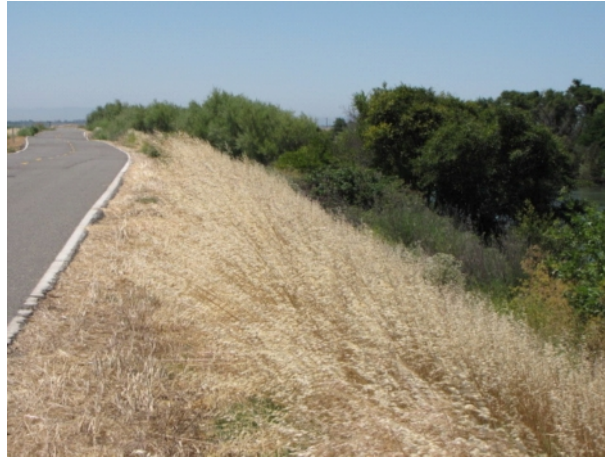
Looking upstream from levee mile 2.77.

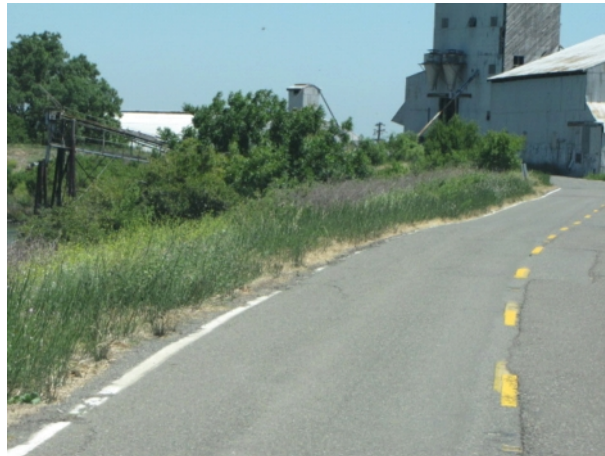
Levee Mile Report Line	10
Start Levee Mile	3.52
End Levee Mile	3.55
Location	Water Side
Category	Earthen Levee
Item	Trim / Thin Trees

Looking downstream from Levee mile 3.52 wild growth has overtaken slope on waterside. Taken 11-03-2010

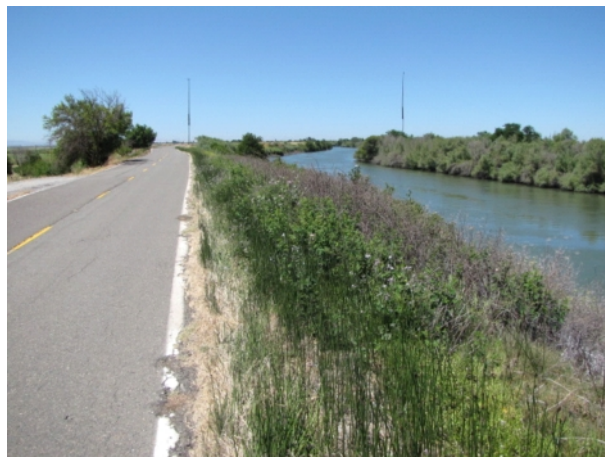
Levee Mile Report Line	10
Start Levee Mile	3.52
End Levee Mile	3.55
Location	Water Side
Category	Earthen Levee
Item	Trim / Thin Trees

Levee mile 3.52 standing on waterside looking upstream wild growth. Photo taken 11-03-2010

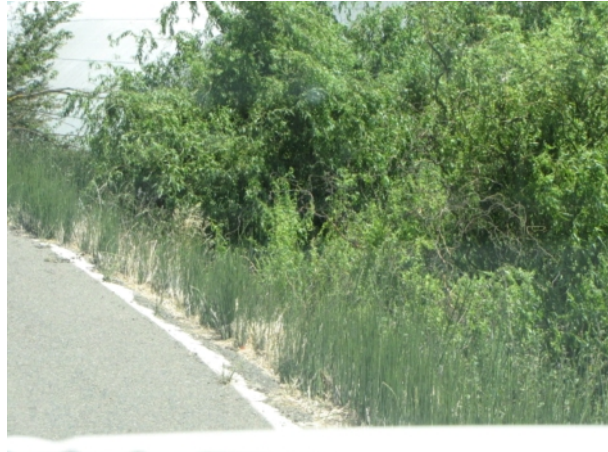
Levee mile 3.55 land side tree growth on slope, you can't see the slope for wild growth. These trees has not been trimmed. Photo taken 11-03-2010

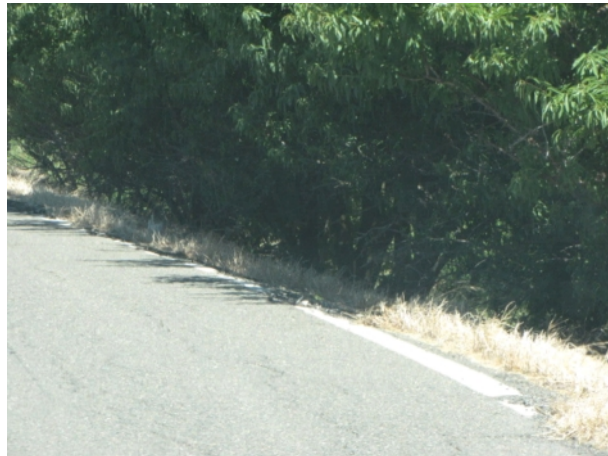
Levee Mile Report Line	12
Start Levee Mile	3.69
End Levee Mile	3.70
Location	Land Side
Category	Earthen Levee
Item	Trim / Thin Trees

Levee mile 3.69 tree growth has blocked view of levee on the land side.

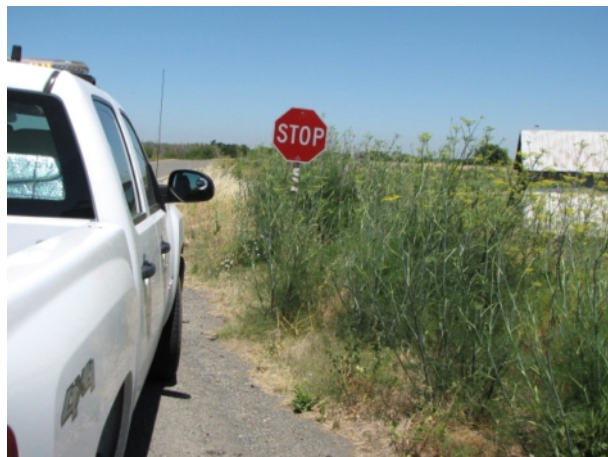
Levee Mile Report Line	12
Start Levee Mile	3.69
End Levee Mile	3.70
Location	Land Side
Category	Earthen Levee
Item	Trim / Thin Trees

Looking downstream from 3.70 tall growth continues down stream from this point. Taken 11-03-2010

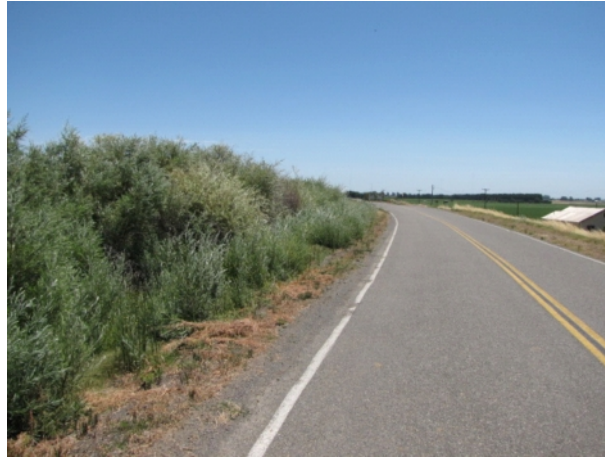
Levee mile 6.43 water side the wild growth blocks view of water ward slope, looking downstream. You can't see the levee section for the wild growth.

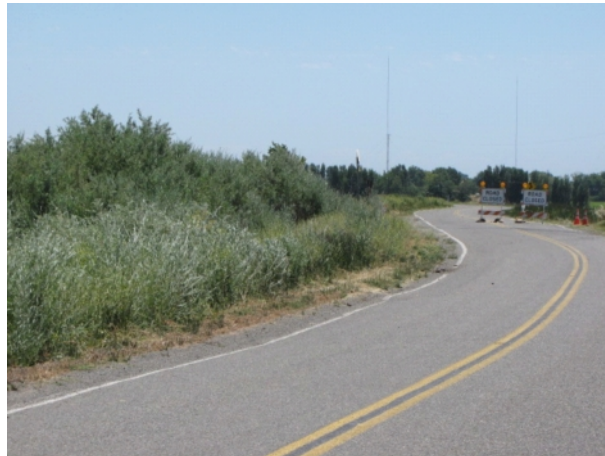
Levee Mile Report Line	17
Start Levee Mile	6.43
End Levee Mile	6.52
Location	Water Side
Category	Earthen Levee
Item	Trim / Thin Trees

Wild growth continues downstream, levee section blocked by growth.

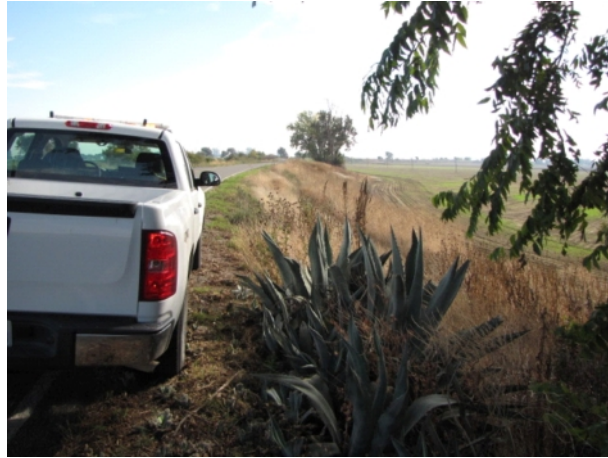
Standing upstream of levee mile 0.00 landside looking downstream of Unit 4 RD 501. Photo taken 11-04-2010

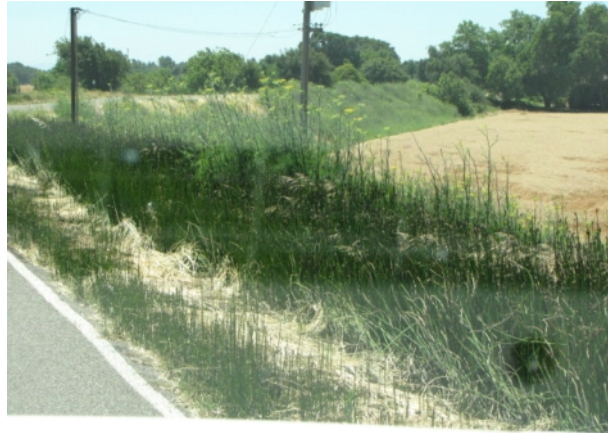
Levee Mile Report Line	3
Start Levee Mile	0.50
End Levee Mile	1.15
Location	Land Side
Category	Earthen Levee
Item	Vegetation

Looking downstream land side wild growth taking over the slope continuing onward downstream to levee mile 1.15

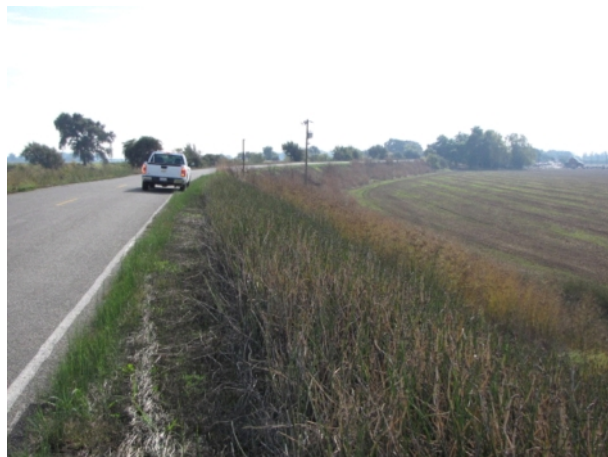
Levee Mile Report Line	3
Start Levee Mile	0.50
End Levee Mile	1.15
Location	Land Side
Category	Earthen Levee
Item	Vegetation

Standing upstream of levee mile 1.15 Unit 4 RD 501 landside looking downstream at wild growth of Horse Tail on levee slope. You can't see the slope for the growth. Taken 11-03-2010

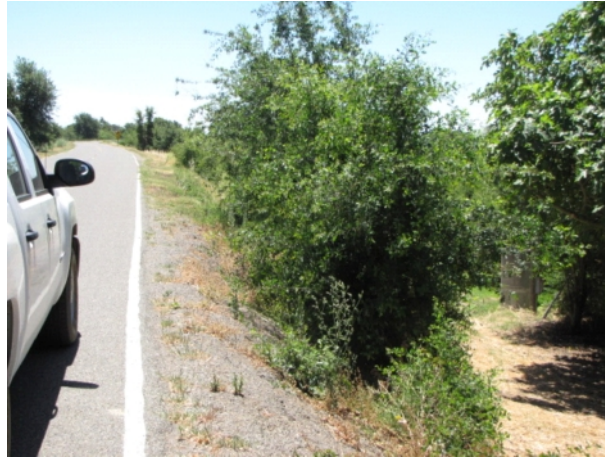
Levee mile 1.84 looking downstream landside oak tree growth cover slope from hinge point to toe as seen in this photo.

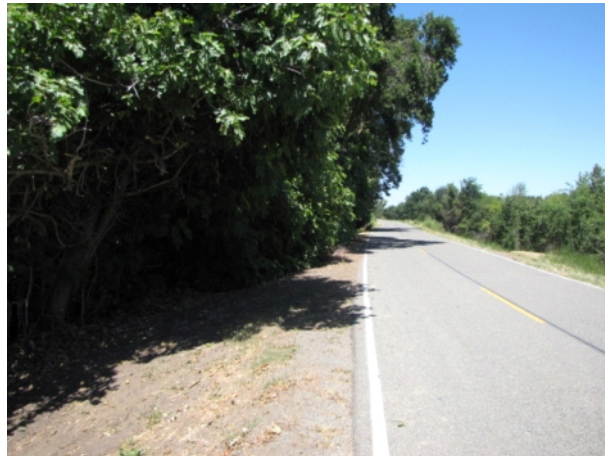
Levee Mile Report Line	11
Start Levee Mile	1.84
End Levee Mile	1.87
Location	Land Side
Category	Earthen Levee
Item	Trim / Thin Trees

Looking back upstream from landside the fig trees has not been maintained, they block the shoulder and slope of the levee section as well as hanging over the levee.

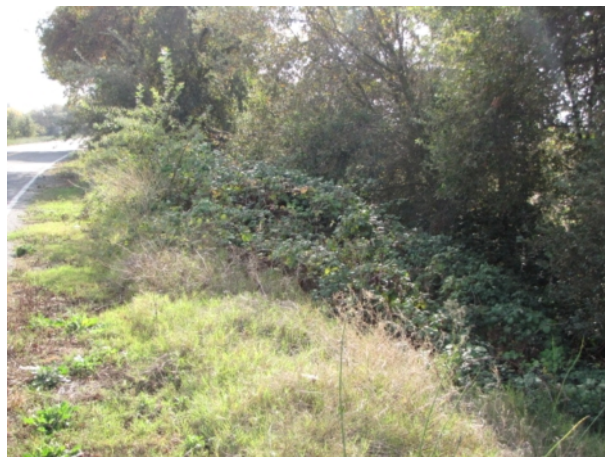
Levee Mile Report Line	13
Start Levee Mile	2.05
End Levee Mile	2.11
Location	Land Side
Category	Earthen Levee
Item	Vegetation

Standing up stream of levee mile 2.05 looking downstream at unsatisfactory growth of wild berries on landside slope toe and shoulder of levee section. Taken 11-03-2010

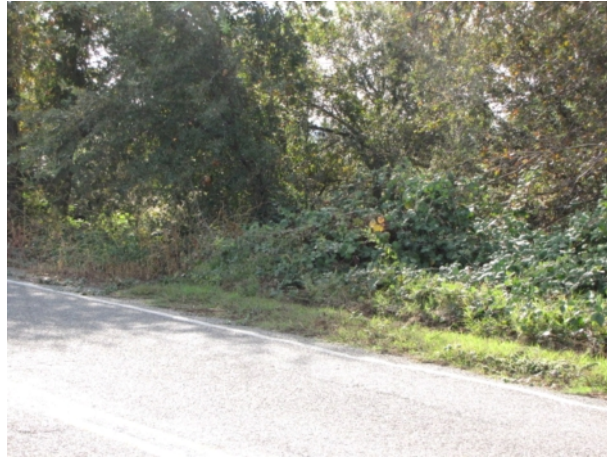
Downstream view of the wild growth of berries on the landside slope unit 4 RD 501, levee mile 2.11. This wild makes impossible to inspect the levee slope. Taken 11-03-2010
